# Commercial Plastic Encapsulated Microcircuits for Naval Aviation Applications

*Anthony Casasnovas and James W. White*

(Keywords: Plastic encapsulated microcircuits, Naval aviation, Long-term dormant storage.)

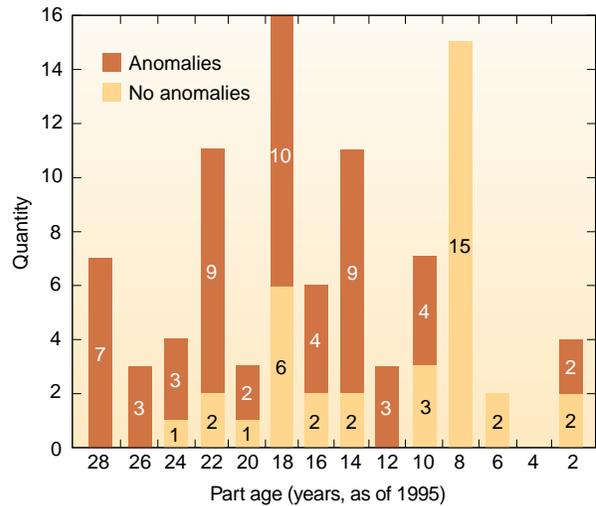
cosmetic appearance of PEMs. Of the 92 samples inspected, only 36 parts had no visual inspection defects. Figure 4 shows the quantity of parts that exhibited anomalies vs. no anomalies by part age. The leading failure modes were lead finish damage (27 cases), twisted leads (23 cases), and contamination from unknown sources (12 cases).

Figure 4. Results from external visual inspection of parts. Long-term dormant storage has a deleterious effect on the cosmetic appearance of plastic encapsulated microcircuits.

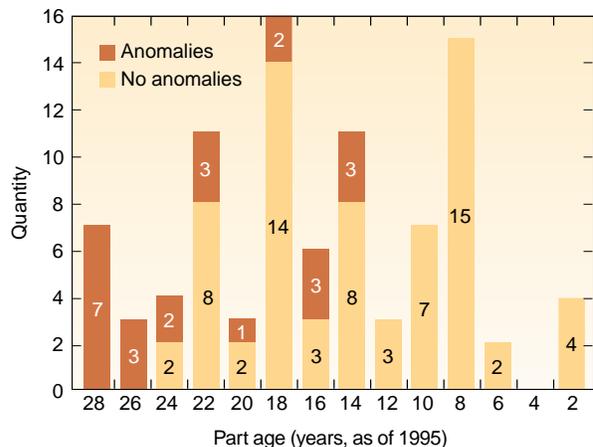
We performed radiographic inspection using MIL-STD-883, method 2012. Of the 92 samples inspected, 68 parts met the MIL-STD-883 criteria. The failure modes detected were inadequate die attach, misalignment, void in molding compound, wire crossing wire (worst offender, 11 cases), and foreign material in encapsulant. None of the failures were a consequence of long-term dormant storage; rather, they were a result of manufacturing and workmanship flaws. Figure 5 presents the quantity of parts that exhibited anomalies vs. no anomalies by part age. Note the improved quality (across all evaluated parts and manufacturers) of the more recently manufactured parts. Figure 6 provides a typical example of the failure mode “wire crossing wire.” Eleven parts exhibited this failure mode. The bond wires presented in Fig. 6 are not in direct contact.

Figure 5. Results from radiographic inspection of parts. Note the improved quality of the more recently manufactured parts.

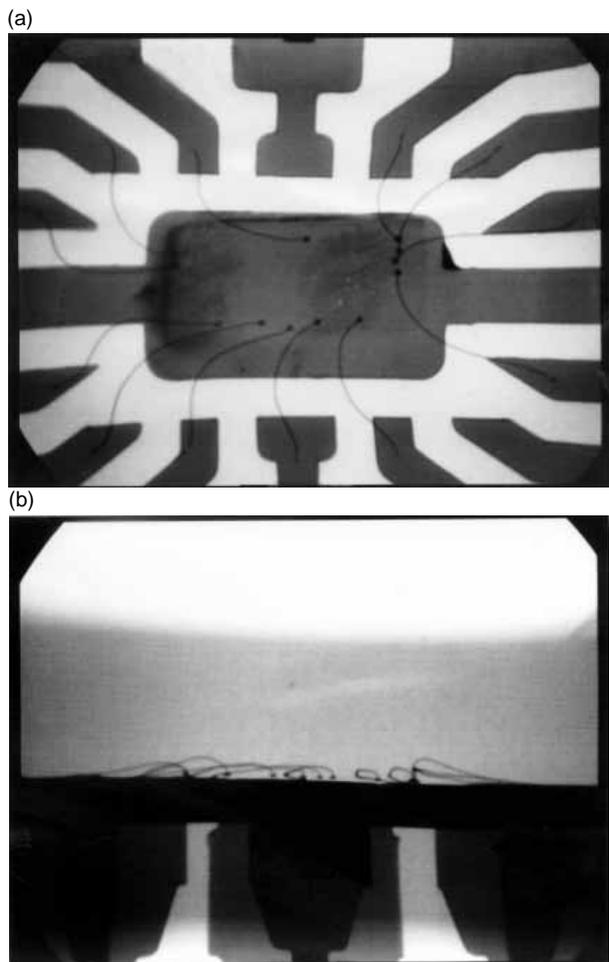
**Figure 6.** “Wire crossing wire” example. This failure mode was the worst offender. These bond wires are not in direct contact, but they are in very close proximity. (a) Top view. (b) Side view.

However, their close proximity could be a cause of electrical rejection due to leakage currents.

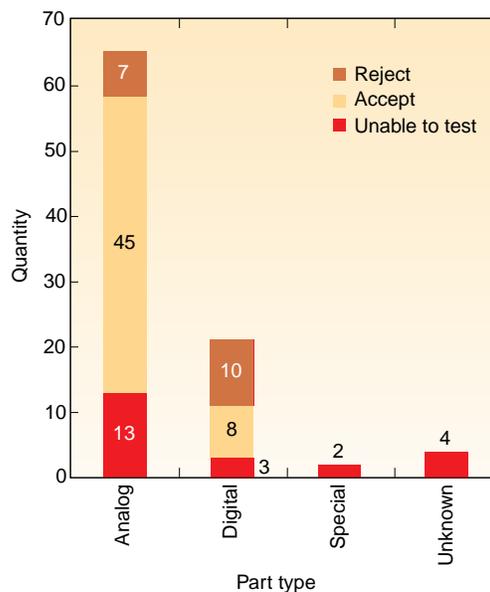
Whenever a suitable automated test equipment program was available, we subjected the parts to electrical testing at room, rated-high, and rated-low temperatures (Fig. 7). Because we do not know if any parts that failed electrical testing were functional on their original manufacturing date, and because of the 17 parts that failed, 9 exhibited the failure mode “wire crossing wire” during radiographic inspection, we minimize the value of the information provided by the electrical testing of those parts. However, for parts that passed electrical testing, we gained confidence that they were good parts when manufactured and remained good during dormant storage. The results of electrical testing at rated-high and rated-low temperatures do not add any value to this discussion. High- and low-temperature testing was performed only in digital parts, and their behavior is consistent with the test results at room temperature.

**Figure 7.** Results from electrical testing of parts at room temperature. Of 92 parts, 53 were accepted, 17 were rejected, and 22 were unable to be tested. Results at high and low temperatures were consistent with this figure.

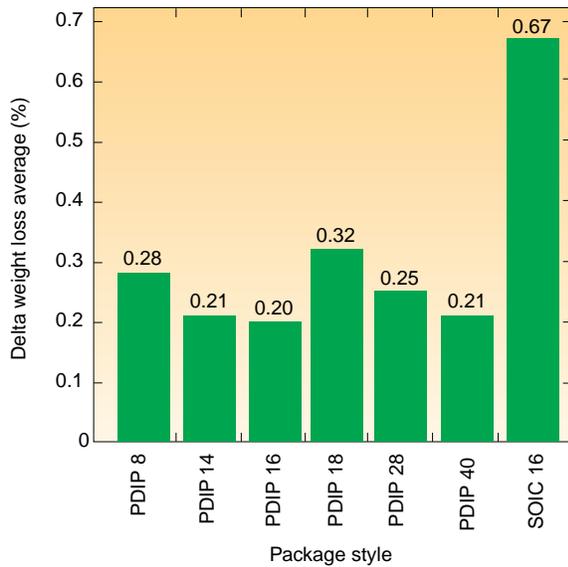
The weight of all parts (before the bake) ranged from 6080 mg to 150 mg; the average was approximately 1036 mg. The part that exhibited the highest delta weight loss (0.67%) was the single 16-pin small-outline integrated circuit (Fig. 8), the smallest and lightest part (149 mg after the bake) of the entire population. This is the only evaluated part at risk for popcorning, which is the package cracking caused by high moisture content that vaporizes and expands rapidly during elevated temperature processes. The resulting force can cause package delamination, internal cracks, bond damage, or, in severe cases, external package cracks. This is commonly referred to as the “popcorn effect” or popcorning, due to the audible pop that the package makes

**Figure 8.** Delta weight loss of parts due to moisture desorption during high-temperature bake. The average weight loss of plastic dual-in-line packages (PDIPs) was 0.25%. (SOIC = small-outline integrated circuit.)

as it cracks.<sup>13</sup> Parts packaged as small-outline integrated circuits are especially at risk because usually they are exposed to high-temperature infrared reflow or vapor phase during final board assembly. This failure mechanism is an assembly concern and is easily prevented by proper component storage and handling or by subjecting the parts to a bake prior to board assembly. The

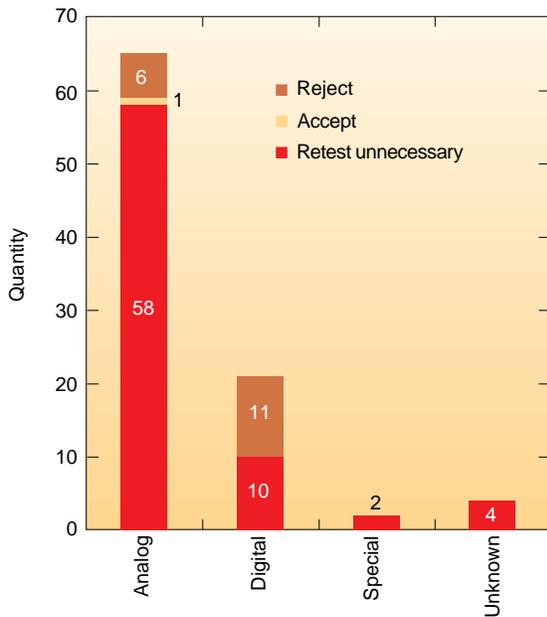
**Figure 9.** Electrical retest of parts that were rejected at initial electrical tests. One analog part, which was a failure at initial electrical testing, passed at room temperature after the high-temperature bake. Of 92 parts, 1 was accepted, 17 were rejected, and 74 did not require retesting.

The parts rejected at initial electrical testing (at any temperature) were subjected to retest at room, rated-high, and rated-low temperatures. One analog part (16 years old), which was a failure at initial electrical testing, passed at room temperature after the bake (see Fig. 9). In addition, one digital part (24 years old), which originally passed electrical testing at room temperature, was rejected at low temperature (and therefore was retested) and passed at high temperature. Then, at retesting, the digital part failed at room temperature, failed at low temperature, and passed at high temperature. Again, we minimize the value of the information provided by these electrical tests.

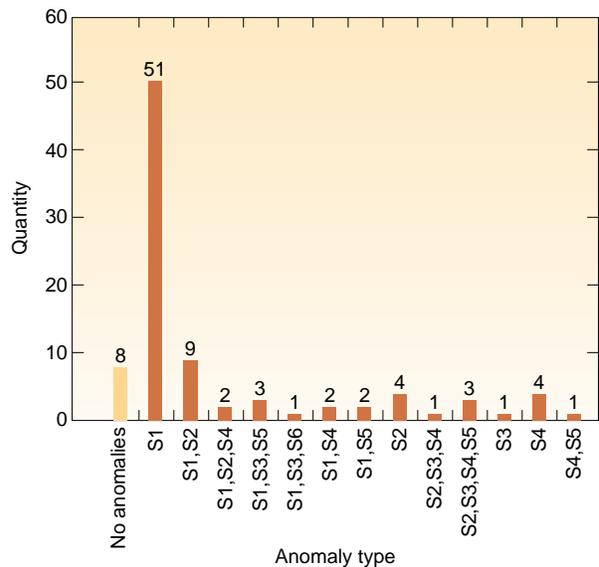
All parts being investigated were subjected to C-mode scanning acoustic microscopy. Of the 92 parts inspected, 84 parts exhibited some degree of delamination (see Fig. 10) ranging from small delamination to 100% delamination on top and/or bottom of the die paddle or die surface. Only eight parts passed C-mode scanning acoustic microscopy inspection without remarks. Figure 11 presets some typical examples of delaminated areas on both old and recent vintage parts. Figure 12 suggests that most parts, despite their age, are likely to exhibit some degree of delamination. These data suggest that C-mode scanning acoustic microscopy

**Figure 10.** C-mode scanning acoustic microscopy results showing types of anomalies. Most parts exhibited some degree of delamination. (S1 = small delamination, S2 = void in die attach, S3 = 100% delamination on bottom of die paddle, S4 = void in molding compound, S5 = 100% delamination on top of die paddle, S6 = delamination on top of die surface.)

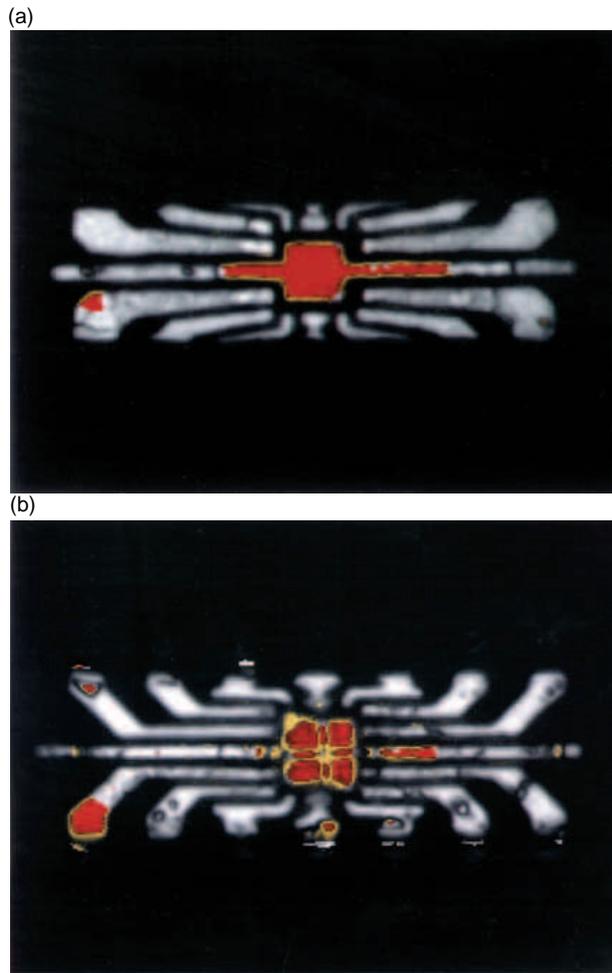
**Figure 11.** Examples of C-mode scanning acoustic microscopy results. (a) 100% delamination on bottom die paddle. (b) 100% delamination on die surface.

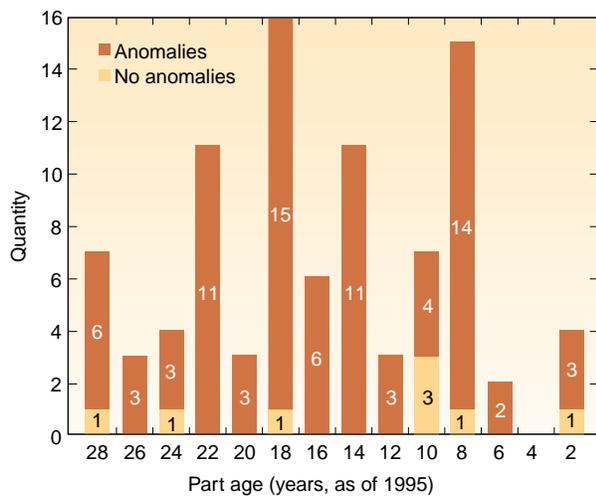
**Figure 12.** C-mode scanning acoustic microscopy results by part age. Regardless of age, most parts exhibited delamination. Therefore, the value added by using C-mode scanning acoustic microscopy for screening plastic encapsulated microcircuits is questionable.

is not a good method for parts screening, although it might be valuable for other purposes.

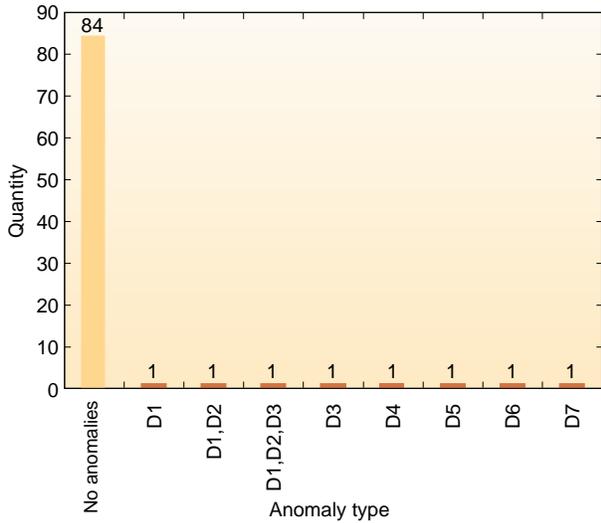
Of 92 parts evaluated, 8 parts were rejected following MIL-STD-883 criteria, as shown in Fig. 14. Two parts were rejected for corrosion (failure mode D3), possibly a result of long-term dormant storage. One part with failure mode D1 (bond pull reject) passed electrical testing at room, low, and high temperatures. Therefore, this rejection was probably a bad bond to begin with and not a consequence of long-term dormant storage. Another part exhibited failure mode D1 (bond pull reject)

**Figure 14.** Destructive physical analysis results showing types of anomalies. Only two cases of corrosion occurred, both in parts that were 28 years old. (D1 = bond pull reject, D2 = intermetallics, D3 = corrosion, D4 = lifting of glass, D5 = void in metallization, D6 = oxide void, D7 = misaligned bond.)

with D2 (intermetallics). This part passed electrical testing at room temperature, and no corrosion was evident. Therefore, this part survived long-term dormant storage with some deterioration. The relation between the failure mode D4 (lifting of glass) and

long-term dormant storage is debatable. We believe that failure mode D4 is not a consequence of long-term dormant storage but rather a consequence of a workmanship flaw and the oxygen plasma etching. In addition, failure modes D5 (void in metallization), D6 (oxide void), and D7 (misaligned bond) are manufacturing flaws that were present at the part's production date. Therefore, of eight rejected parts, six are not a consequence of long-term dormant storage. Finally, all rejected parts were 18 years or older, as shown in Fig. 15.

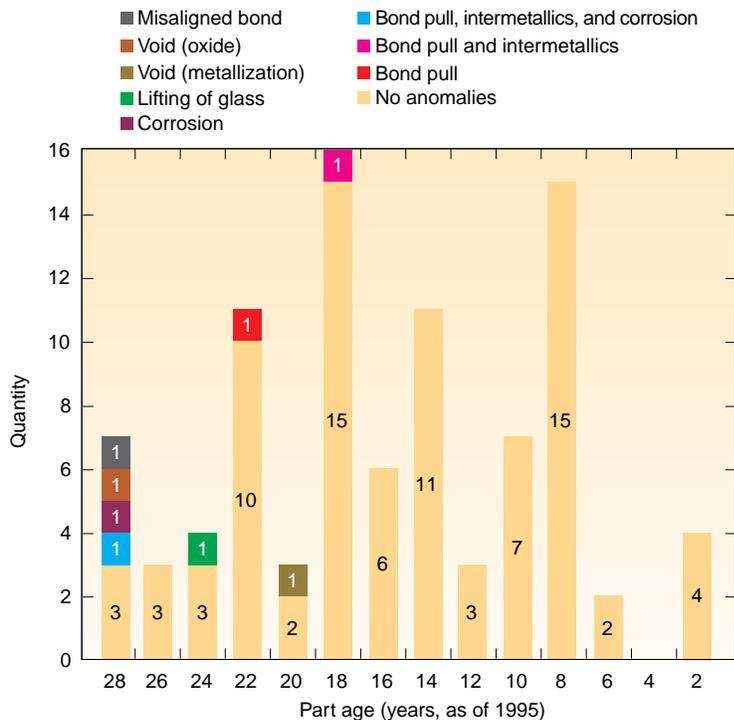
**Figure 15.** Destructive physical analysis results by part age. Regardless of failure mode, all parts noted for defects during destructive physical analysis were 18 years or older.
