EROSION STUDIES ON SOLAR MAX SAMPLES

Samples from the Solar Max satellite were retrieved for inspection after more than four years' exposure to the space environment. Efforts were made to identify the most likely erosive processes and responsible species.

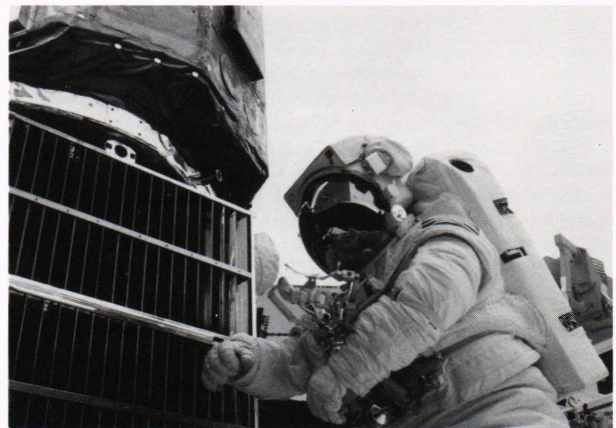
Figure 1—An astronaut repairs Solar Max, replacing sections to be returned to earth. (Photograph courtesy of NASA.)

The Solar Max satellite, which failed due to malfunction of the inertial reference system after more than four years in orbit, was retrieved and repaired during the third shuttle mission in April 1984 (Fig. 1). The damaged pieces were returned to earth and portions were distributed to interested groups for examination. APL received three samples (shown in Fig. 2): (a) a 110- by 120-millimeter section of a protective blanket (composed of Kapton®, Dacron®, and aluminized Mylar®), (b) a 44- by 47-millimeter section of silver-coated Teflon® that had been shaded from the sun, and (c) a 33- by 54-millimeter section of silver-coated Teflon, portions of which had been exposed to the sun.

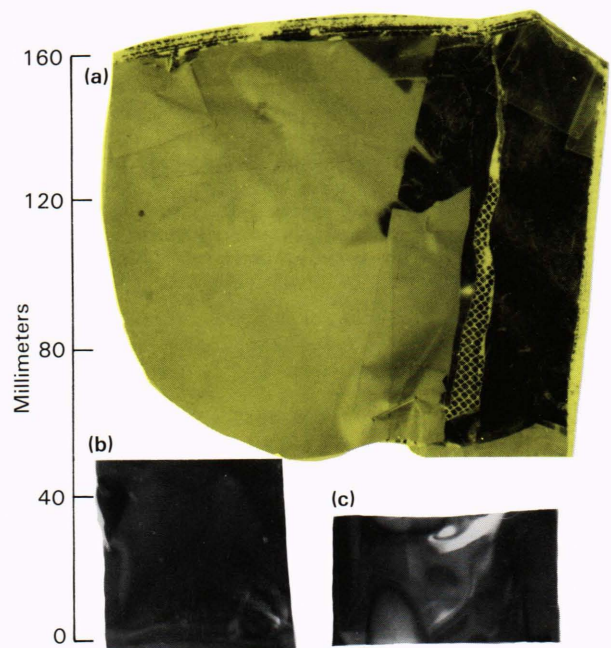
Figure 2—The Solar Max materials provided to APL: (a) the blanket; (b) the unexposed portion; and (c) the exposed portion.

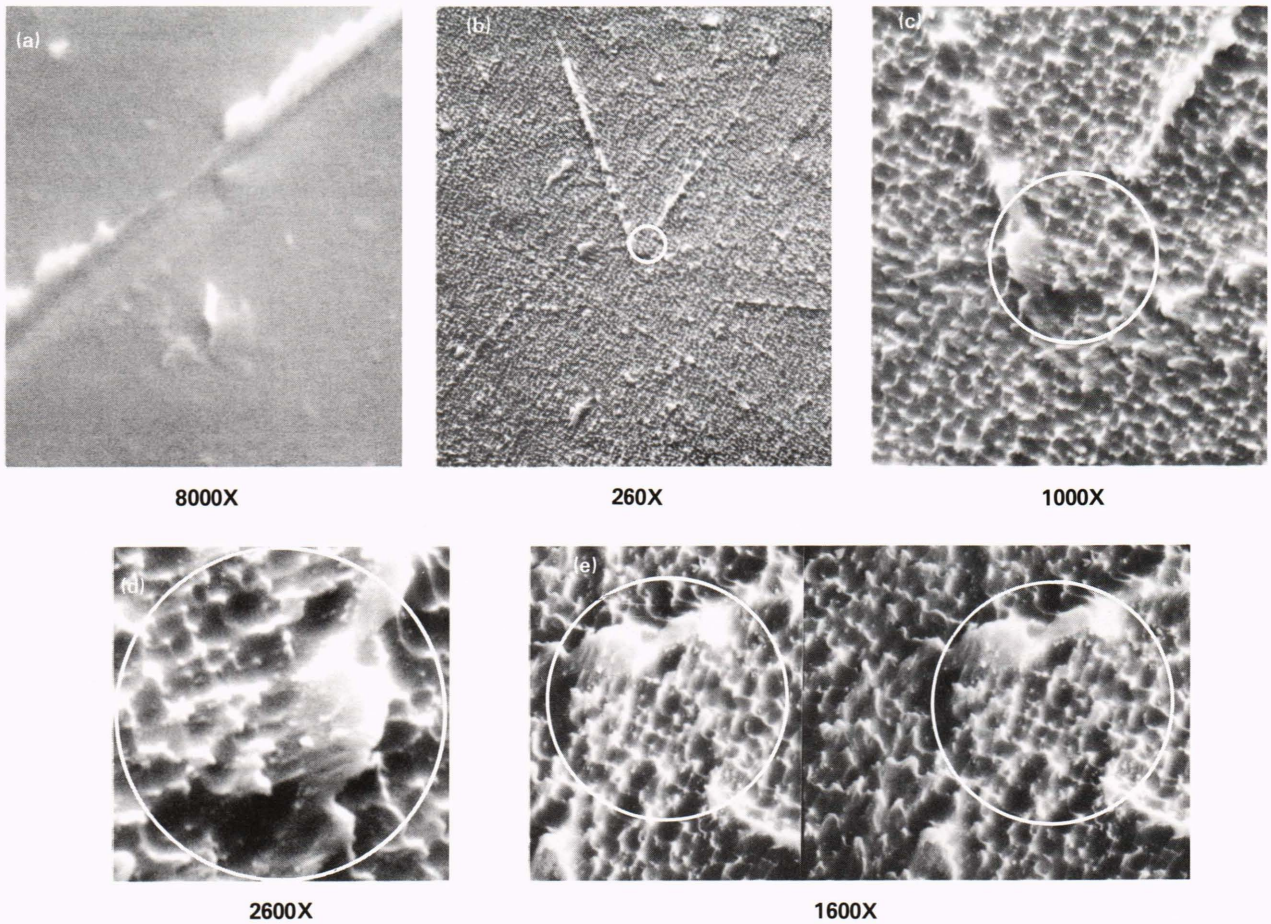
Figure 3—Scanning electron micrographs of unexposed and exposed surfaces of Kapton under various magnifications. (a) The unexposed surface is smooth (having a visually shiny surface) with a few scratches and particulates on the surface. (b), (c), (d) The exposed surface is comparatively roughened, resulting visually in a loss of gloss (matte finish), raised lines, and a few particulates less etched than the surrounding surface. (e) The stereoscopic effect of the pair can be seen by placing a card vertically separating the two images from direct binocular view and relaxing the eyes to bring the image of each eye into coincidence.

Superficial erosion was examined using scanning electron microscopic pictures under high magnification, up to 8000 power. Scanning electron micrographs of unexposed and exposed Kapton are shown in Fig. 3. The

micrographs suggest a chemical type of etching that produces a wavelike pattern that is presumably due to the inherent microstructure of the polymer. The exposed surface is rather rough, resulting in a dull appearance. Several raised lines were also etched out, suggesting lines of stress in the polymer. Many scratches were observable under backlighting, probably resulting from rough handling at some point. No contaminant elements were detected above atomic number 8, the lower limit of the X-ray system.

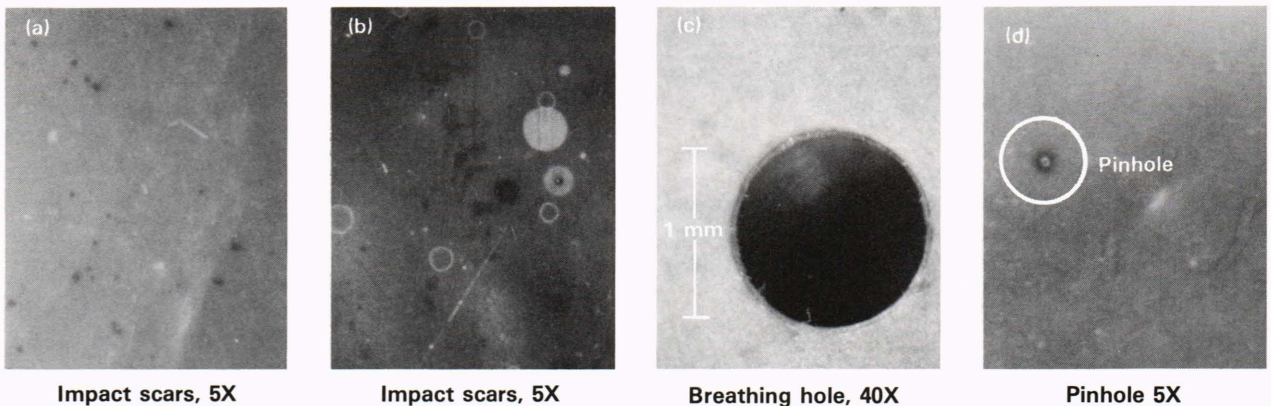
Figure 4—Optical micrographs showing possible impact scars (a and b), a breathing hole (c), and a pinhole (d) in the Kapton blanket.

The outer Kapton layer of the blanket had an array of holes 3 millimeters in diameter to allow water vapor and trapped gases to escape. In addition to these normal breathing holes, backlighting showed several apparent pinholes. No evidence for pinholes was observed on the underlying Mylar sheet, suggesting that any impacting material became volatile before penetrating the Mylar. The pinholes were about 0.1 millimeter in diameter and were circular. More extensive studies with the scanning electron microscope showed that they were imperfections in the aluminum backing of the Kapton, not impact holes.

Optical and electron microscopic observations of both the Kapton and Teflon samples show a number of other areas that do appear to result from impacts. Examples are shown in Fig. 4. However, none of them shows true penetration or the residue of any element above atomic number 8. Although this does not rule out impacts by ice or carbonaceous particles, it does rule out iron meteorites unless one wishes to postulate a clean hit.

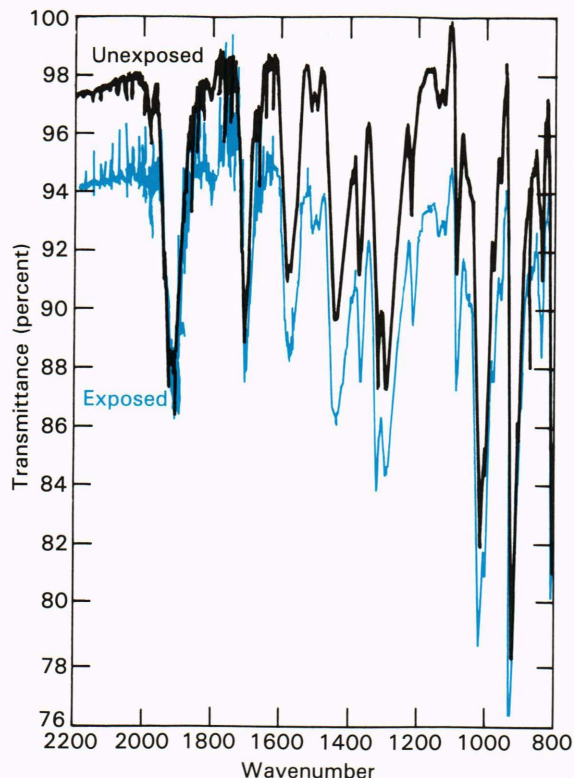
Figure 5—Comparison of Fourier transform infrared spectra of exposed and unexposed Kapton. No significant differences were observed between the two spectra.

Fourier transform infrared spectroscopy was performed in the hope of detecting changes in the polymer structure. No significant differences were observed in the exposed Kapton sample as compared with the matched unexposed sample (Fig. 5). Since the method probes the top few microns of the sample, any chemical changes

restricted to the near-surface region (the upper 2 to 3 nanometers) would be obscured by the large signal from the bulk polymer.

Thus, in the case of Kapton, exposure roughens or etches the surface while the residual bulk-polymer structure remains essentially unchanged.

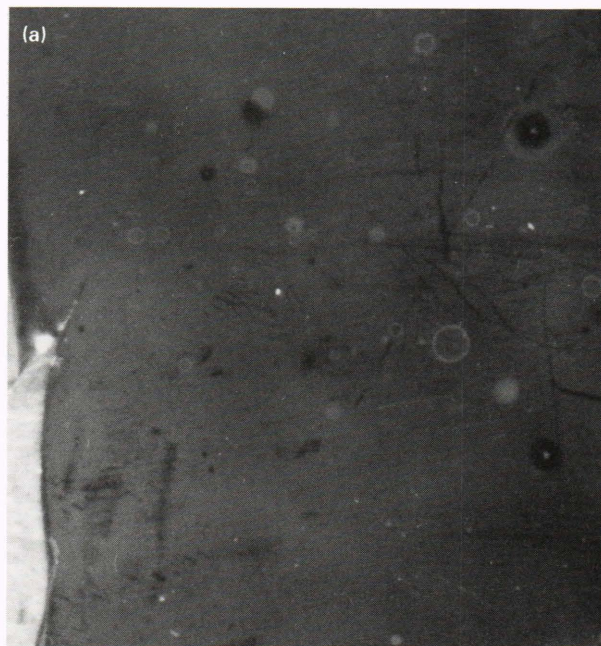
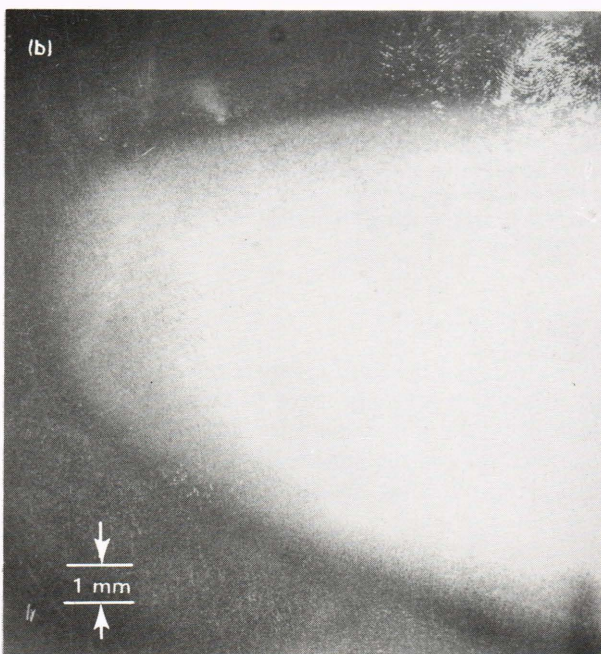
Figure 6—Optical micrographs of silver-coated Teflon showing (a) impact scars and (b) the light-assisted erosion boundary with in which most of the silver has been removed from the surface. The magnification is 5 power for both photographs.

The sample of silver-coated Teflon appears to be severely eroded in the area exposed to sunlight. A few islands of silver remain in the eroded area, and there is an increase of island size as the boundary is approached (Fig. 6). Many degradation cracks were found in the illuminated area where the silver coating is not visible (Fig. 7). A small amount of silver remains in this area, as is indicated by the X-ray analysis.

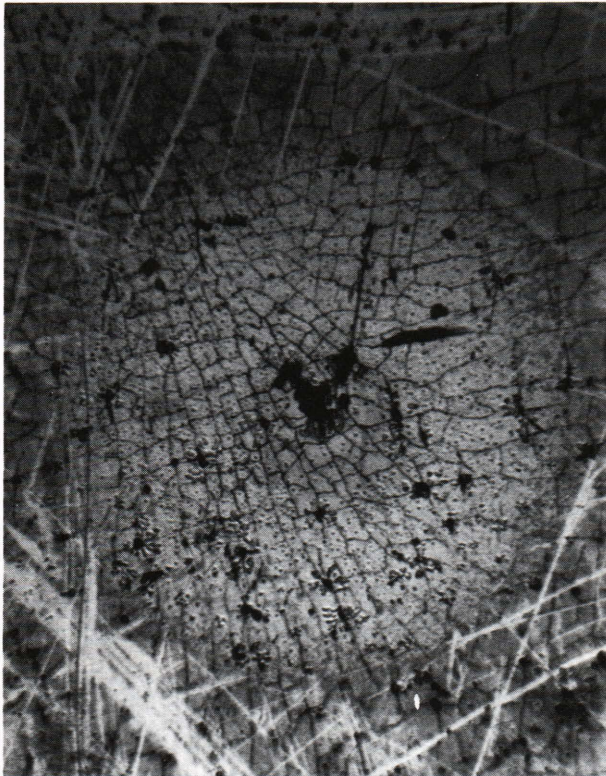
Figure 7—Optical micrograph (30 power) of the eroded silver-coated Teflon surface. According to X-ray analysis, only a small amount of silver remains in the heart of the eroded area. Many degradation cracks are observed in the Teflon in the sun-illuminated area.
