# Commercial Plastic Encapsulated Microcircuits for Naval Aviation Applications

*Anthony Casasnovas and James W. White*

(Keywords: Plastic encapsulated microcircuits, Naval aviation, Long-term dormant storage.)

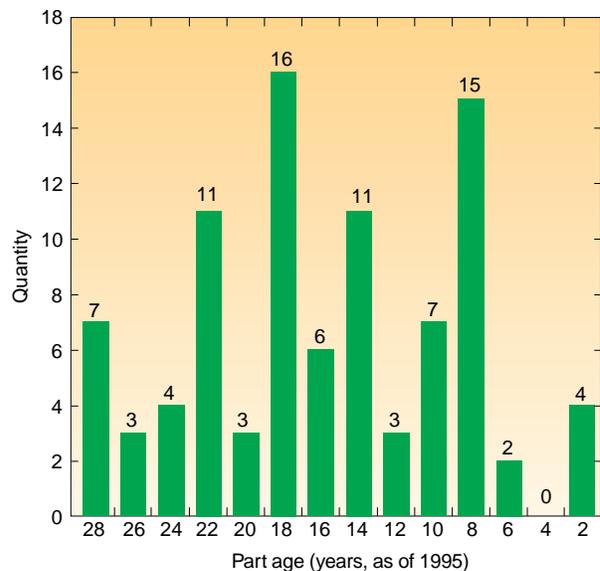
**Figure 1.** Age distribution of evaluated parts. The average age was approximately 16 years. The oldest part exhibited a date code of 6716 (manufactured in the 16th week of 1967).

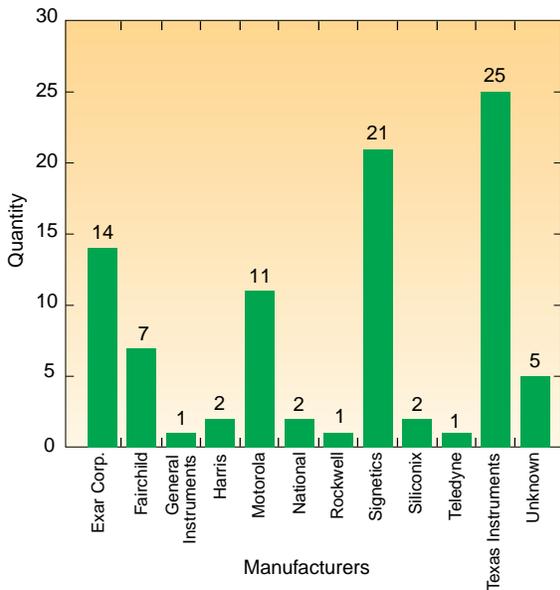
Figure 2. Manufacturers of evaluated parts.

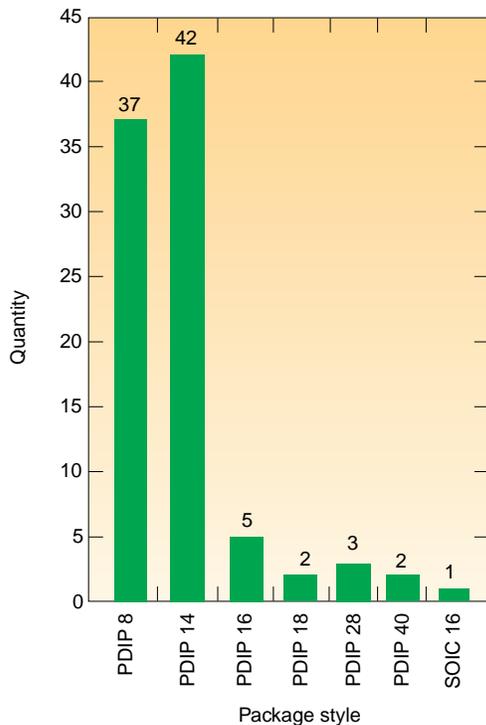
Figure 3. Package style distribution of parts. All parts except one were plastic dual-in-line packages (PDIPs). A single small-outline integrated circuit (SOIC) was evaluated as well.

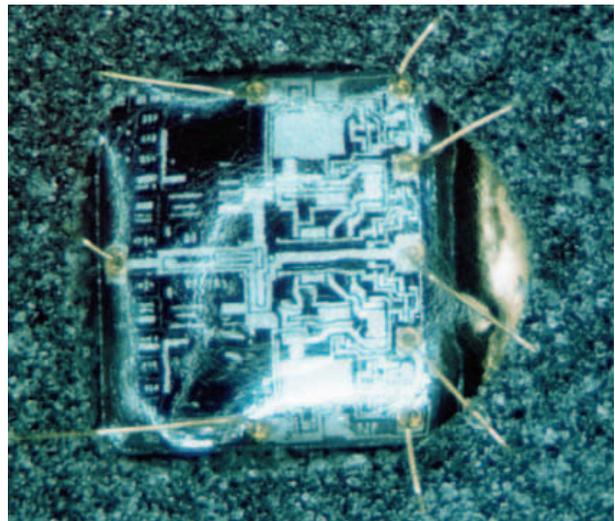
All parts were subjected to destructive physical analysis. The physical decapsulation was accomplished using an oxygen plasma etching system (see Ref. 16). This method, as shown in Fig. 13, proved to be highly effective in exposing the die without damaging the surface or the bond wires. In some parts, a chemical rinse using fuming nitric acid was done to complete the process.

**Figure 13.** Oxygen plasma etching is a very effective method for exposing the die surface and the bond wires.
